What's With All the Water?

Construction Manager, Dawson City Waste Water Treatment Plant

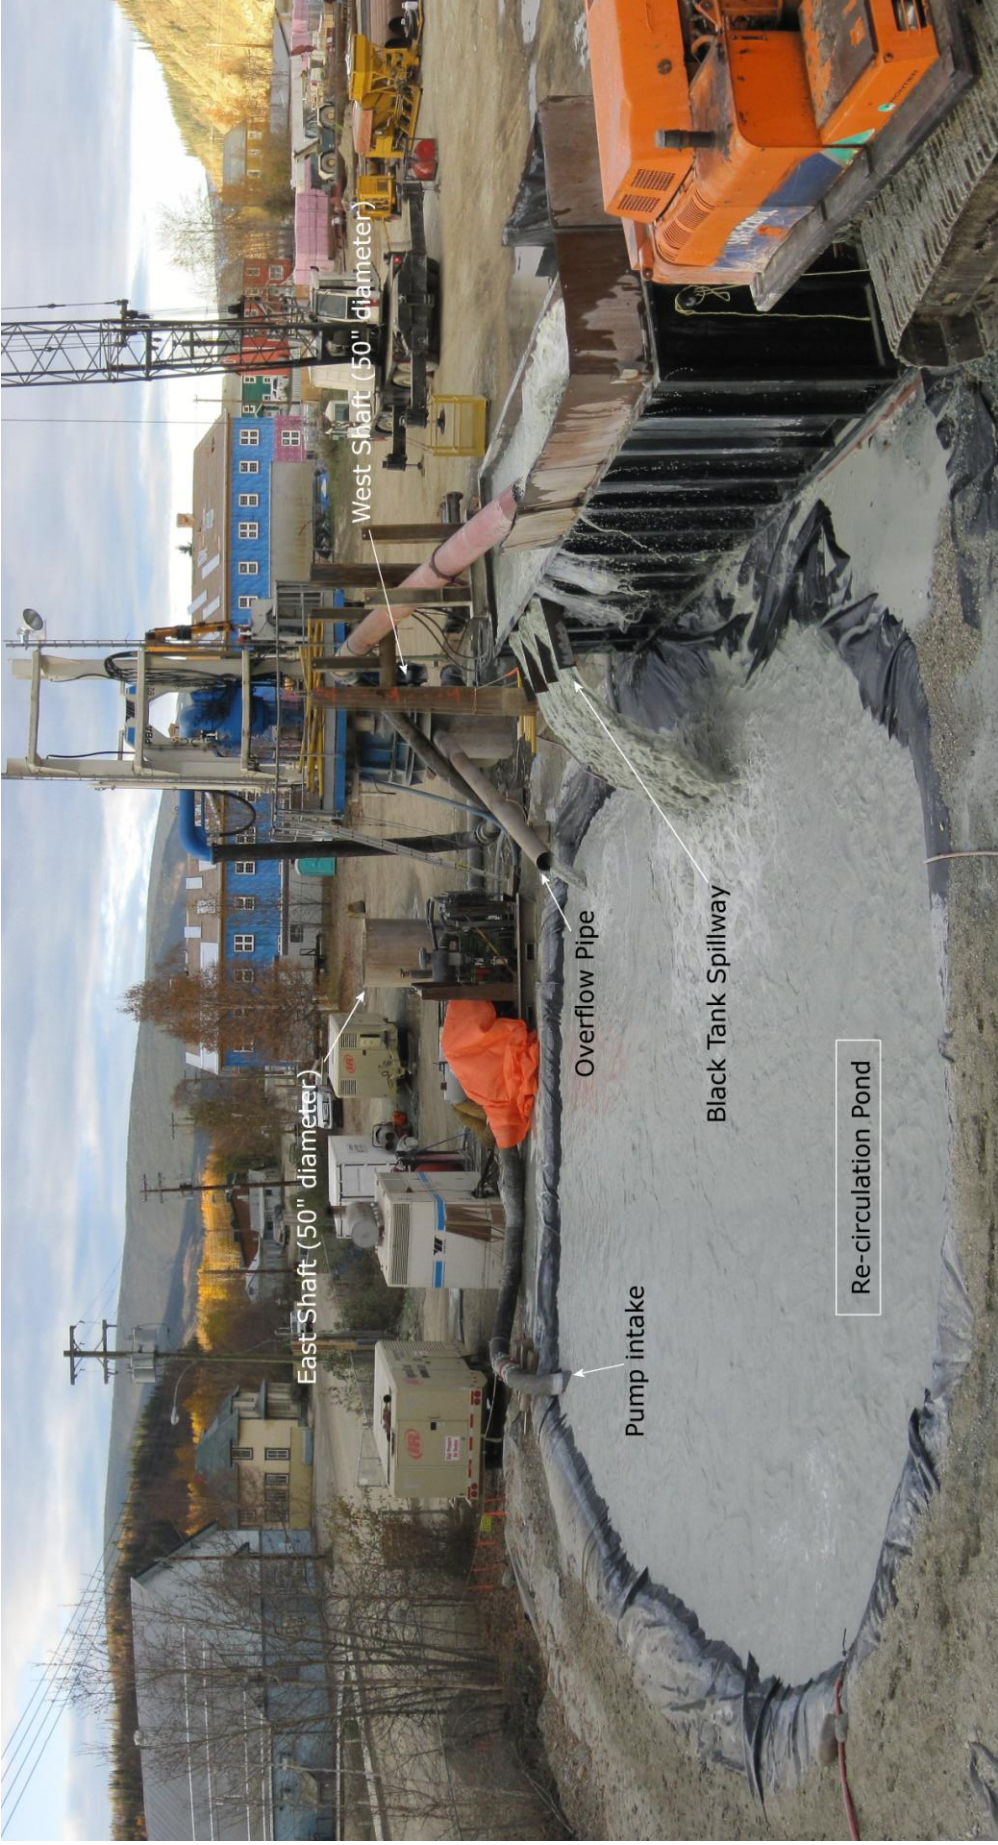
East Shaft (50" diameter)

West Shaft (50" diameter)

Pump intake

Overflow Pipe

Black Tank Spillway

Re-circulation Pond

On the south side of the Screening Plant, a pond 2 metres (6.5 feet) deep was excavated in August and lined with a 30 mil (0.8 mm) thick engineered plastic sheet. The sole purpose of the pond was to hold water used for drilling the 2 main shafts in which will sit the influent pipes and air lines that form part of the new sewage treatment system. The 2 shafts are some 96 metres (315 feet) in depth from the surface of the ground.

But where did the water come from? To begin with, the pond was filled with potable water from the fire hydrant on the other side of Fifth Avenue by the Locomotive Museum. A suction line was placed at the southeast corner of the pond and a pump running continuously, drew water from the pond and dropped it into the large round casing that the drill machine sat on. The pipe from the casing back to the pond was used as an overflow. That maintained a proper level of water over the drill bit and helped to stabilize the shafts. As the bit progressed into the rock, the air supplied to the bit caused a Venturi (suction) effect and started the cuttings up the air lift. The air then forced cuttings and water up the drill pipe and through the blue rotary head at the top of the drill, through a large diameter rubber hose and pipe into the black tank located on the west side of the pond. The cuttings were deposited into the black tank and the water then overflowed a baffle and back into pond over the 3 spillways.
